Home Report

Scottish Single Survey

Single Survey

Property address	2 Garthwaite Close Ecclefechan Lockerbie DG11 3DW
Customer	K Pattullo, Trustee of Uzma Naz
Customer address	2 Garthwaite Close Ecclefechan Lockerbie DG11 3DW
Prepared by	Shepherd Chartered Surveyors
Date of inspection	03/12/2025

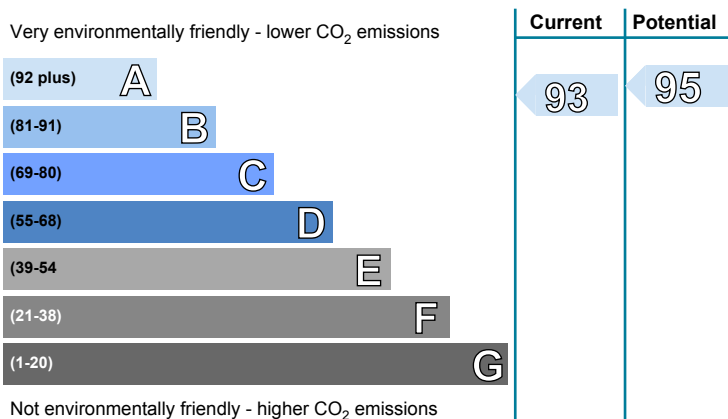
Environmental Impact (CO₂) Rating

This graph shows the effect of your home on the environment in terms of carbon dioxide (CO₂) emissions. The higher the rating, the less impact it has on the environment.
