# YOUR ONESURVEY HOME REPORT

4 Westpark Cottages  
Dumfries  
DG2 7SN

# SINGLE SURVEY

A report on the condition of the property, with categories  
being rated from 1 to 3.

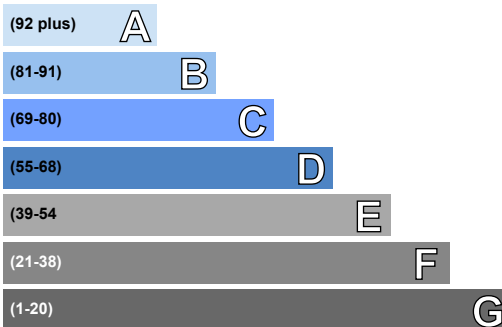
Very environmentally friendly - lower CO<sub>2</sub> emissions

Not environmentally friendly - higher CO<sub>2</sub> emissions
